OCTOBER 1964

THE NAVAL AVIATION SAFETY REVIEW

WHO PULLED THE CURTAIN

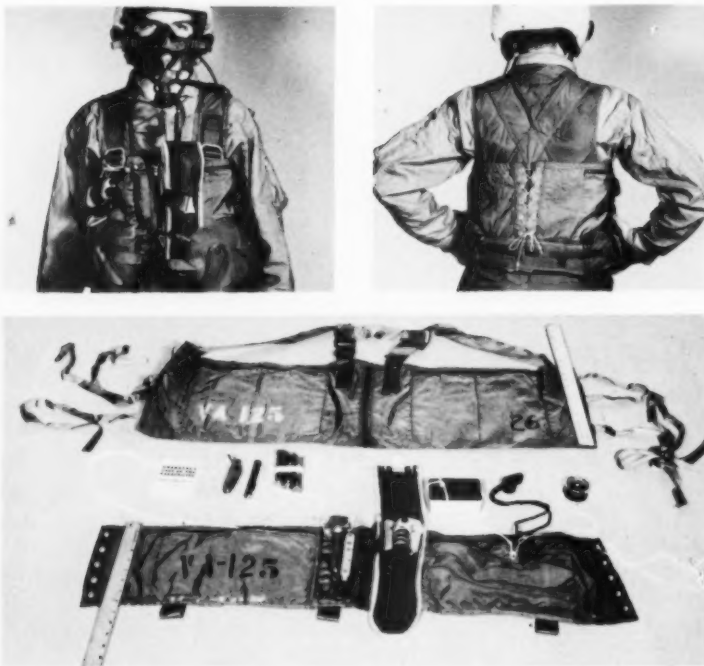
This modified SV-1 survival vest was developed by VA-125. The vest is not permanently fixed to the torso harness. It uses the Mk-3C retainer straps which keeps the vest from rising up and obstructing the rocket jet fittings. Placement of the survival knife and shroud cutter gives maximum accessibility. The squadron reports that modification of the SV-1 vest requires two man-hours.

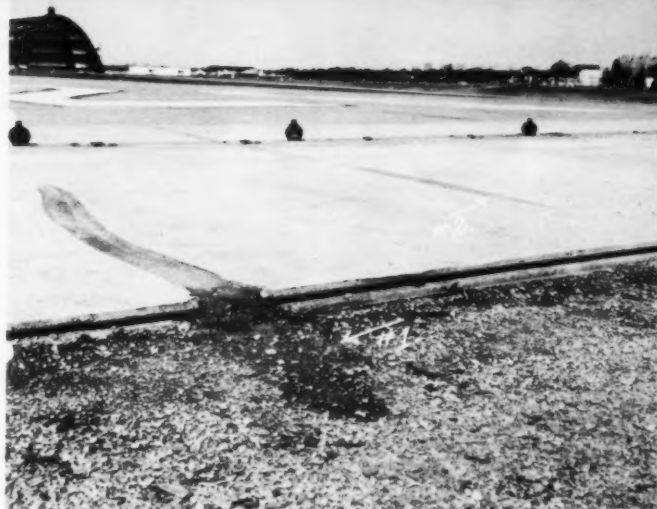
Final resting place inside the "infield."

of a hard landing and impact against a 4-inch runway lip. The A-4 continued up the runway on the port wing tank and other two wheels approximately 2000 feet before it gently turned left and skidded onto the grass. As a final act of defiance to the world, the *Skyhawk* demolished the 4000 ft runway marker as it left the runway. The aircraft came to rest about 140 ft within the "infield" with the altimeter still indicating 420 ft of altitude remaining (the 20,000-ft rattlesnake that didn't strike in this accident).

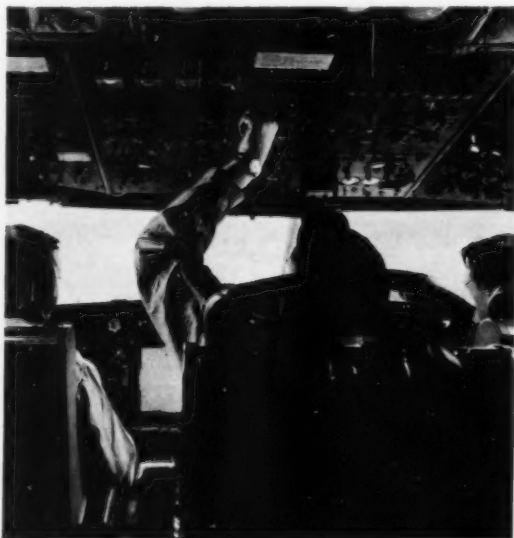
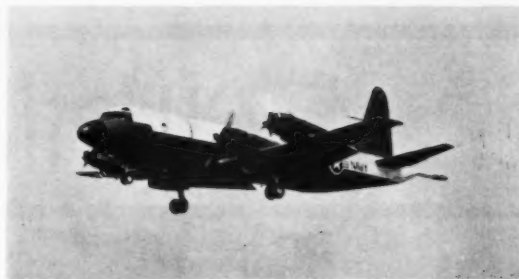
Penetration Turn—This is nice and easy, having no course reversal to invite vertigo! You couldn't stall in this attitude without conscious effort. Thirty degrees of bank is usually too much—with inbound course cranked into the Horizontal Situation Indicator system, all one needs to do is run a pursuit curve to the course by keeping the lubber line on the tip of the course bar until it holds steady. The drift correction solution falls out automatically.

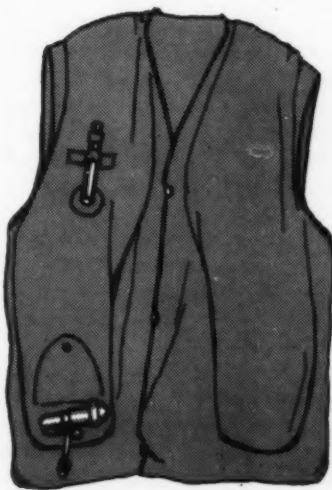
The vest is $\frac{1}{2}$ body length and is collarless. It has full arm openings and a three-snap front. The design is intended for manufacture in various identifying colors and is sized to be worn over either working chambray shirt or foul weather jacket. It is made of two layers of loosely woven, soil-resistant material which hold a U-shaped, single-cell flotation bladder. The bladder inflates with one 7.9 gram to 8.8 gram CO_2 cartridge or an oral inflation tube.

The vest does not have automatic inflation at this time. However, when such a device is perfected, it should be so constructed as to be readily installed onto the present CO_2 discharge fitting. In the present design, one breath equals 10 lbs. of buoyancy, one breath plus one CO_2 cylinder discharge equals 20 lbs. of buoyancy. Fully inflated, the vest gives 20 to 30 lbs. of buoyancy.

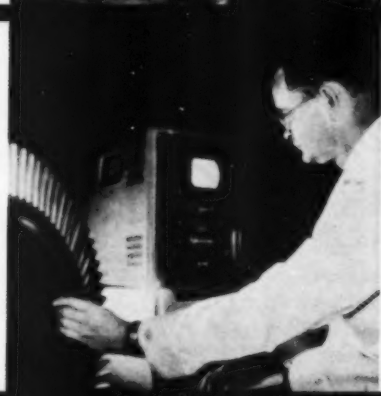
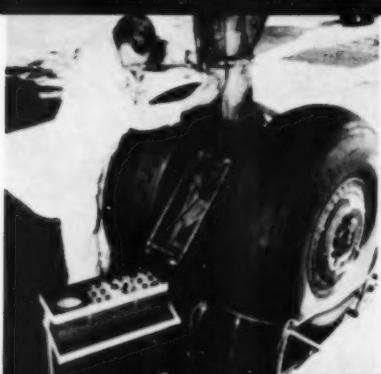
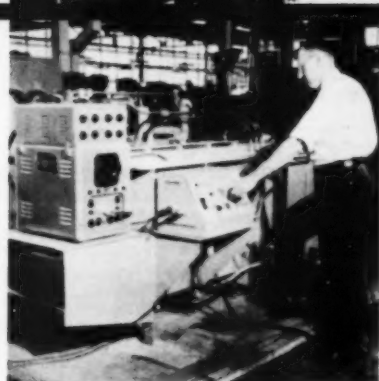
STRAIGHT BEAM SEARCH UNIT. Used to locate defects by projecting a beam perpendicular to the test surface.

ANGLE BEAM SEARCH UNIT. Used to locate defects by introducing a beam of vibrations at an angle to the surface of the test material. Testing sheet and plate are among the applications for the angle beam method.

PREVENTIVE MAINTENANCE. Programmed maintenance, using the portable Reflectoscope for on-the-spot, nondestructive testing of an aircraft landing gear saves dollars in assuring equipment reliability and public satisfaction and confidence. Costly unpredictable failures are prevented. Throughout industry, such programmed inspection can facilitate scheduled parts replacement, or planned obsolescence of components can be accomplished with minimum down time and maximum equipment protection.

IN PRODUCTION. Quality control on the production line, either automated high speed testing or manual piece inspection, can often be accomplished with ultrasonics more conveniently and less expensively than other test methods. Sperry Simac automated inspection systems can register the presence of defects in material at production speeds. Automatic signalling and marking devices indicate the exact location.

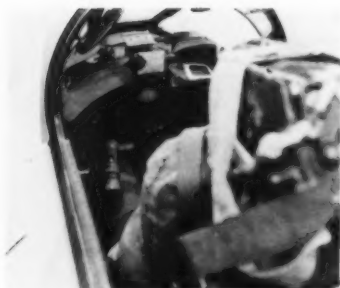
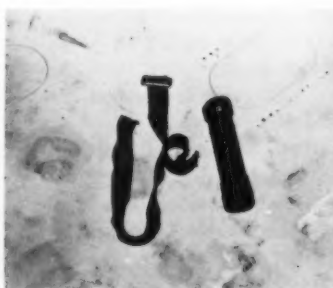
Flashlight Strap

Light holder on left leg . . . easily made from looped webbing.

FPO, San Francisco—Re the discussion on how to attach the two-cell flashlight, our pilots are well satisfied with the following device: two pieces of elastic webbing sewn together to form two loops, the small loop closed by a lift-the-dot fastener, the larger by a buckle. The large loop fits around the leg just above the knee and the smaller holds the flashlight. The photos show the simple construction and easy use.
